## Annual Inspection

Brington Parish Council

Kimbells Field Play Area

Back Lane, Great Brington, NN7 4JQ

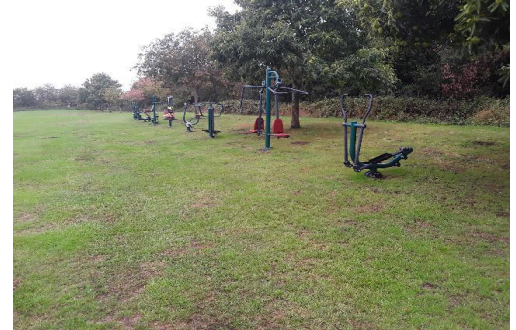
**Item:** Site General  
**Manufacturer:** Not Applicable  
**Surface Type:** Mixed Surface  
**Item Quantity:** 1  
**Equipment Compliance:** N/A  
**Surface Area Compliance:** N/A

There are holes in the grass surface that may cause users to trip or roll ankles - Infill to provide a sound reasonably level surface.

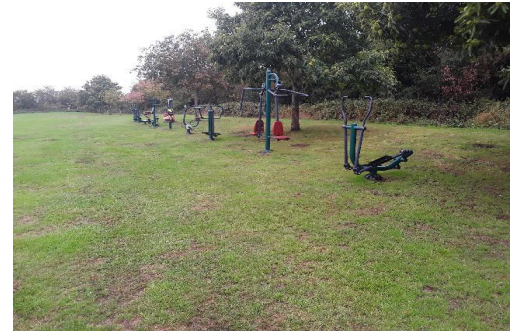
**Item:** Sign  
**Manufacturer:** Not Applicable  
**Surface Type:** N/A  
**Item Quantity:** 1  
**Equipment Compliance:** N/A  
**Surface Area Compliance:** N/A

Signage should be provided for the outdoor fitness equipment in accordance with the requirements of BS EN 16630, key requirements of the sign include, but are not limited to, intended users, medical safety and emergency contact details - Provide appropriate signage

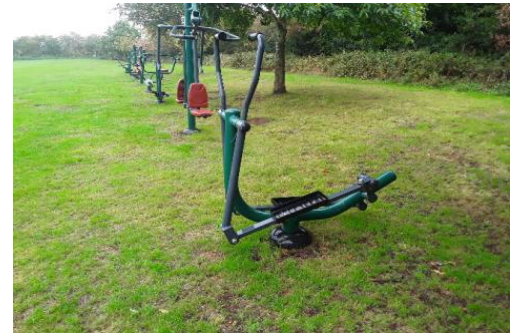
**Item:** Cross Trainer  
**Manufacturer:** Sunshine Gym  
**Surface Type:** Grass Matrix Tiles  
**Item Quantity:** 1  
**Equipment Compliance:** Yes  
**Surface Area Compliance:** Yes

The paintwork on this item has been damaged or worn exposing the metal underneath which is rusting / corroding - Treat affected areas and repaint

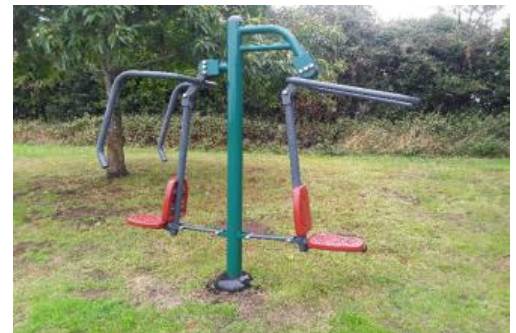
**Item:** Double Fitness Station  
**Manufacturer:** Sunshine Gym  
**Surface Type:** Grass Matrix Tiles  
**Item Quantity:** 1  
**Equipment Compliance:** Yes  
**Surface Area Compliance:** Yes

This item is satisfactory - no work required -

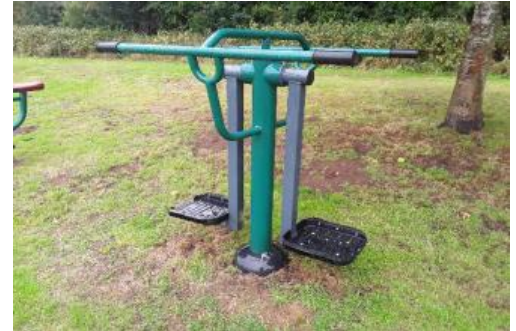
**Item:** Air Skier  
**Manufacturer:** Sunshine Gym  
**Surface Type:** Grass Matrix Tiles  
**Item Quantity:** 1  
**Equipment Compliance:** Yes  
**Surface Area Compliance:** Yes

This item is satisfactory - no work required -

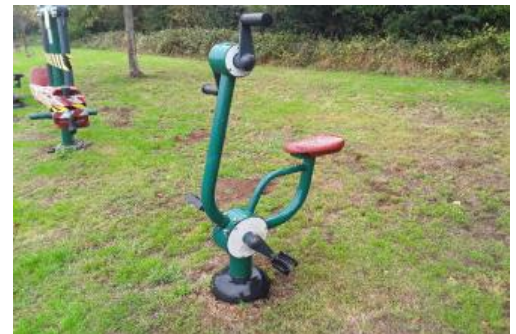
**Item:** Hand Bike  
**Manufacturer:** Sunshine Gym  
**Surface Type:** Grass Matrix Tiles  
**Item Quantity:** 1  
**Equipment Compliance:** Yes  
**Surface Area Compliance:** Yes

This item is satisfactory - no work required -

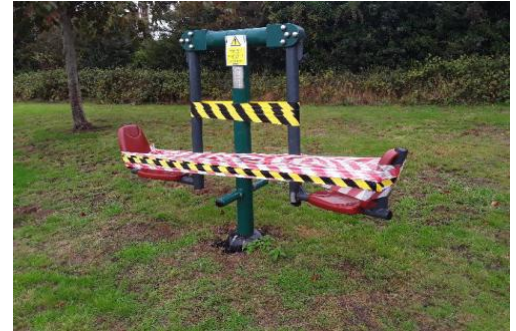
**Item:** Leg Press  
**Manufacturer:** Sunshine Gym  
**Surface Type:** Grass Matrix Tiles  
**Item Quantity:** 1  
**Equipment Compliance:** N/A  
**Surface Area Compliance:** N/A

The item was damaged at the time of the inspection and a full inspection could not be undertaken - Carry out the required repairs and inspect for stability

The weld(s) on this item have failed / the seat support has been damaged - Repair the damaged components

The area equipment has been isolated from use however the area is still accessible and the means of isolation has either introduced additional hazards that may cause harm in the event of users accessing the area or is insufficient to stop users from accessing the equipment - Provide a more suitable isolation method

The paintwork on this item has been damaged or worn exposing the metal underneath which is rusting / corroding - Treat affected areas and repaint

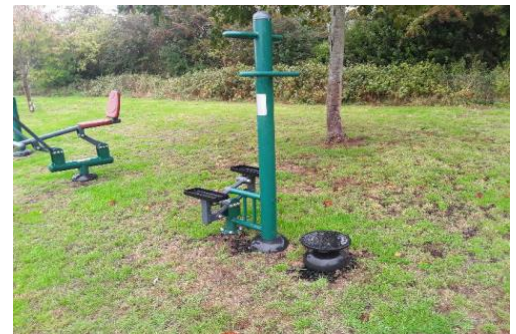
**Item:** Double Fitness Station  
**Manufacturer:** Sunshine Gym  
**Surface Type:** Grass Matrix Tiles  
**Item Quantity:** 1  
**Equipment Compliance:** Yes  
**Surface Area Compliance:** Yes

The instruction label has faded and has become illegible; an instruction label should be provided with each item of equipment in accordance with the requirements of BS EN 16630 - Provide appropriate instruction label/s

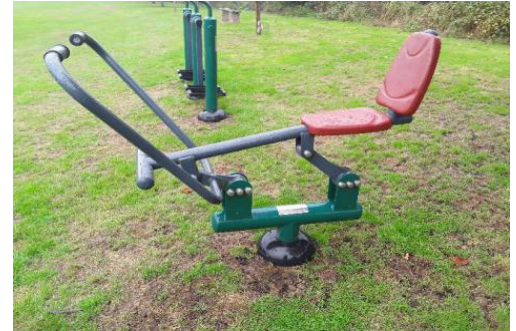
**Item:** Rower  
**Manufacturer:** Sunshine Gym  
**Surface Type:** Grass Matrix Tiles  
**Item Quantity:** 1  
**Equipment Compliance:** Yes  
**Surface Area Compliance:** Yes

There is/are bolt cap covers missing or damaged on the item - Replace missing or damaged bolt cap covers

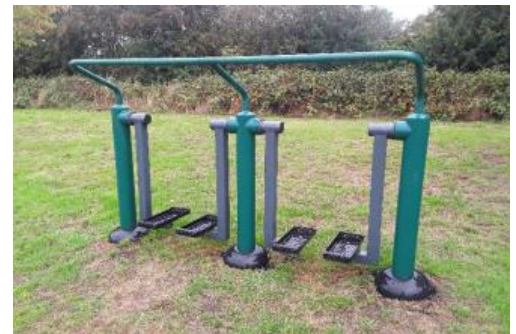
**Item:** Double Air Walker  
**Manufacturer:** Sunshine Gym  
**Surface Type:** Grass Matrix Tiles  
**Item Quantity:** 1  
**Equipment Compliance:** Yes  
**Surface Area Compliance:** Yes

This item is satisfactory - no work required -

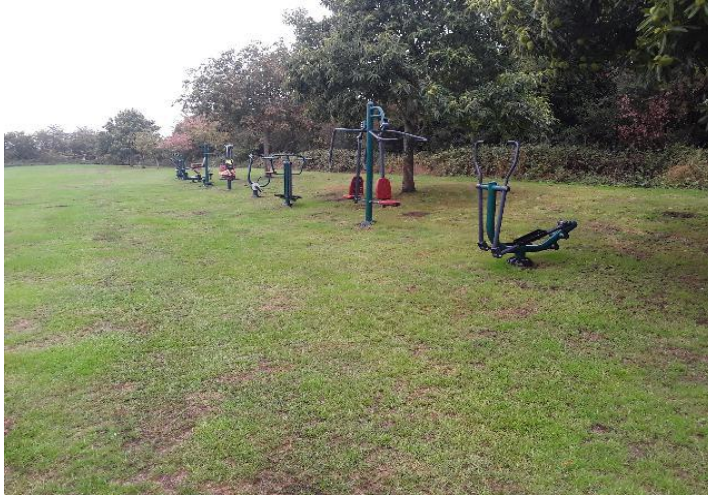
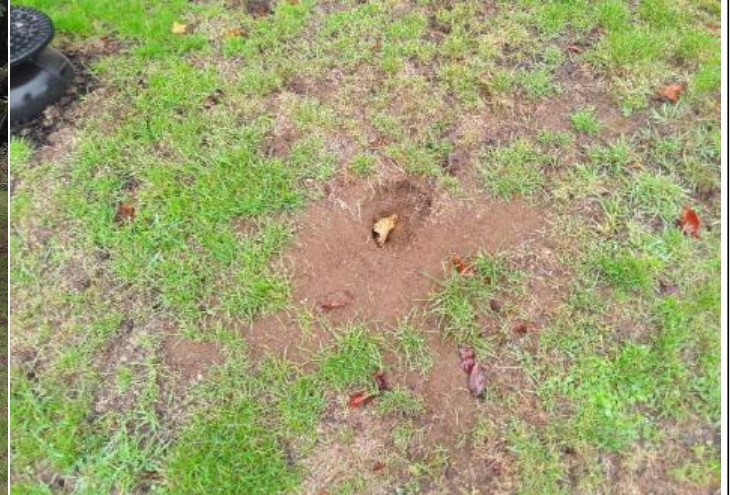
**Item:** Ancillary Items - Site General  
**Manufacturer:** Not Applicable

**Finding:** There are holes in the grass surface that may cause users to trip or roll ankles

**Action:** Infill to provide a sound reasonably level surface.

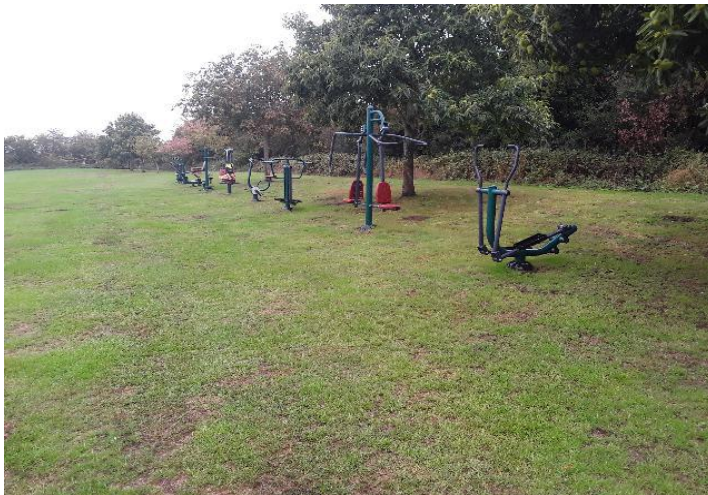
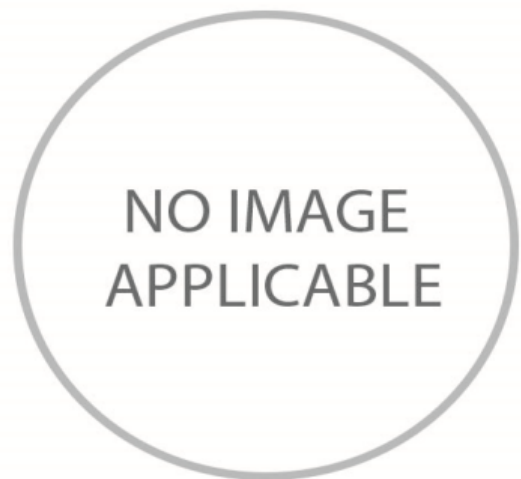
**Item:** Ancillary Items - Sign  
**Manufacturer:** Not Applicable

**Finding:** Signage should be provided for the outdoor fitness equipment in accordance with the requirements of BS EN 16630, key requirements of the sign include, but are not limited to, intended users, medical safety and emergency contact details

**Action:** Provide appropriate signage

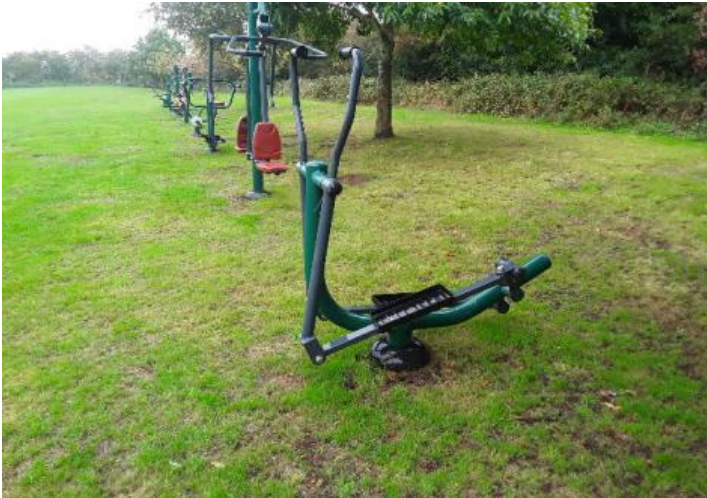
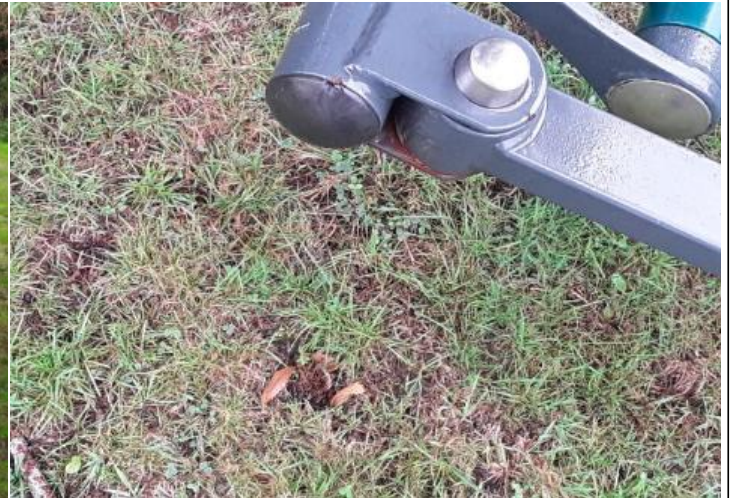
**Item:** Outdoor Fitness Equipment - Cross Trainer  
**Manufacturer:** Sunshine Gym  
**Risk Level:** L - Low Risk  
**Surface:** Grass Matrix Tiles

**Finding:** The paintwork on this item has been damaged or worn exposing the metal underneath which is rusting / corroding  
**Action:** Treat affected areas and repaint

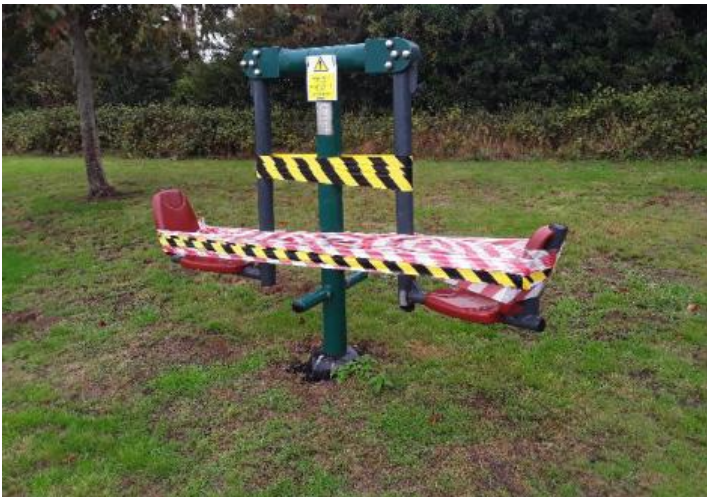
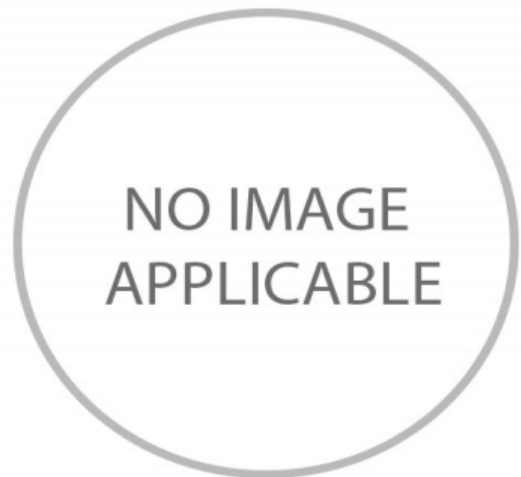
**Item:** Outdoor Fitness Equipment - Leg Press  
**Manufacturer:** Sunshine Gym  
**Risk Level:** N - Risk Assessment not Undertaken  
**Surface:** Grass Matrix Tiles

**Finding:** The item was damaged at the time of the inspection and a full inspection could not be undertaken  
**Action:** Carry out the required repairs and inspect for stability

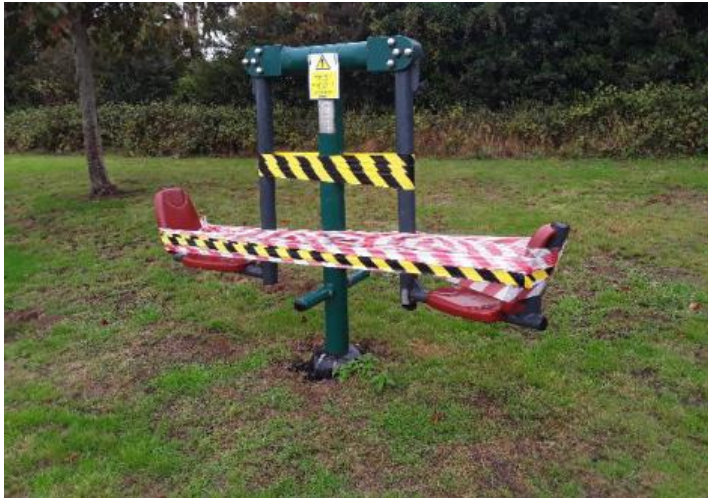
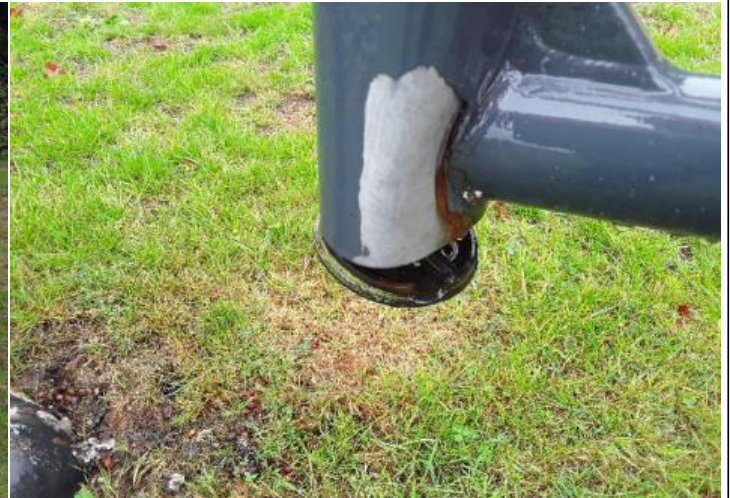
**Item:** Outdoor Fitness Equipment - Leg Press  
**Manufacturer:** Sunshine Gym

**Finding:** The weld(s) on this item have failed / the seat support has been damaged

**Action:** Repair the damaged components

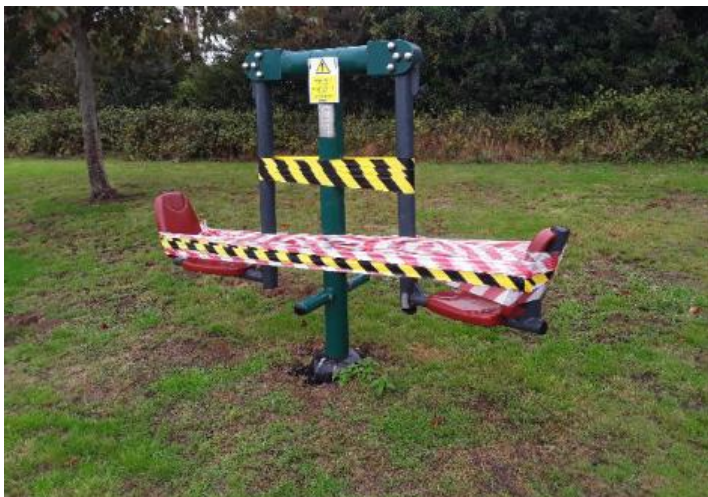
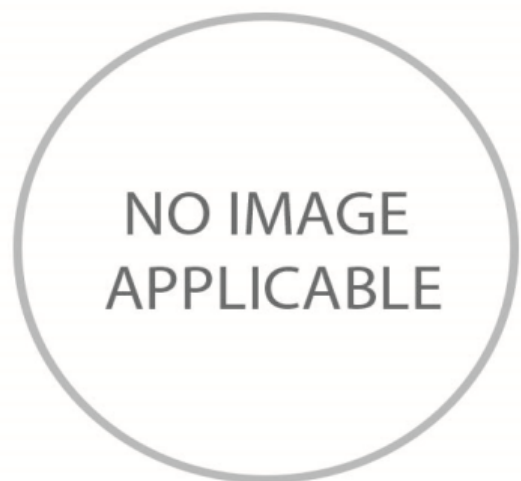
**Item:** Outdoor Fitness Equipment - Leg Press  
**Manufacturer:** Sunshine Gym

**Finding:** The area equipment has been isolated from use however the area is still accessible and the means of isolation has either introduced additional hazards that may cause harm in the event of users accessing the area or is insufficient to stop users from accessing the equipment

**Action:** Provide a more suitable isolation method

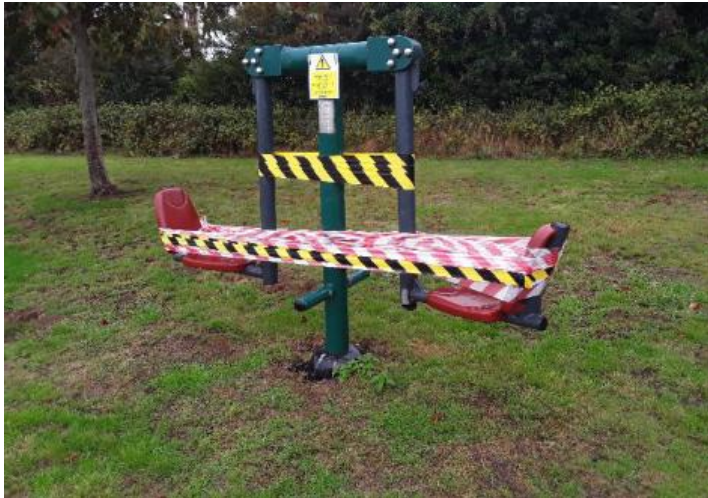
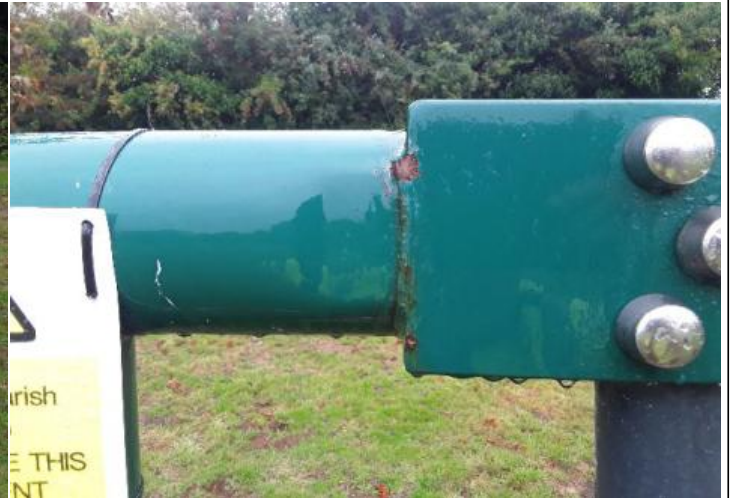
**Item:** Outdoor Fitness Equipment - Leg Press  
**Manufacturer:** Sunshine Gym

**Finding:** The paintwork on this item has been damaged or worn exposing the metal underneath which is rusting / corroding

**Action:** Treat affected areas and repaint

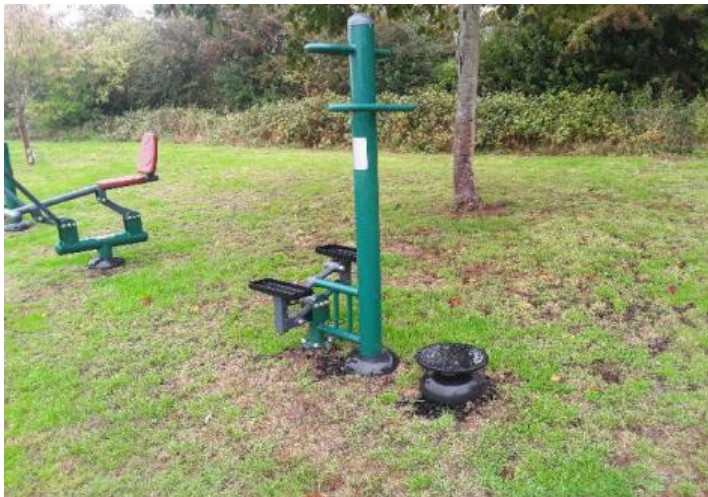
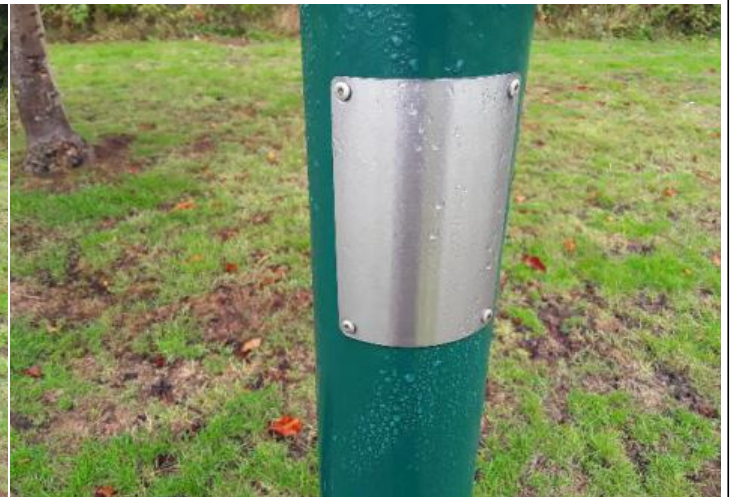
**Item:** Outdoor Fitness Equipment - Double Fitness Station  
**Manufacturer:** Sunshine Gym

**Finding:** The instruction label has faded and has become illegible; an instruction label should be provided with each item of equipment in accordance with the requirements of BS EN 16630

**Action:** Provide appropriate instruction label/s

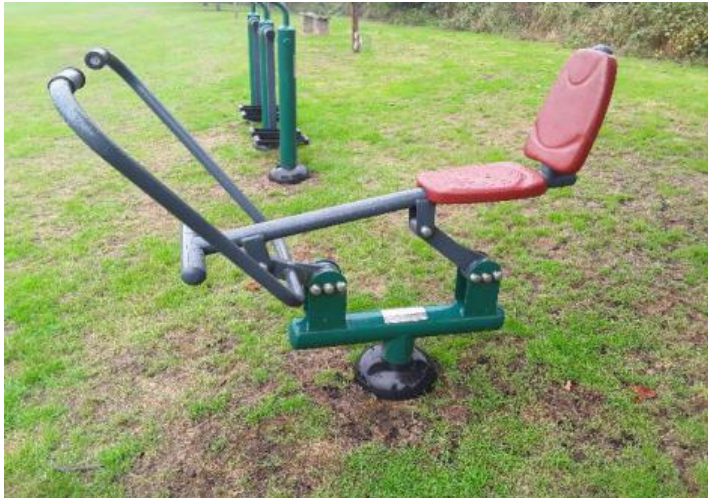
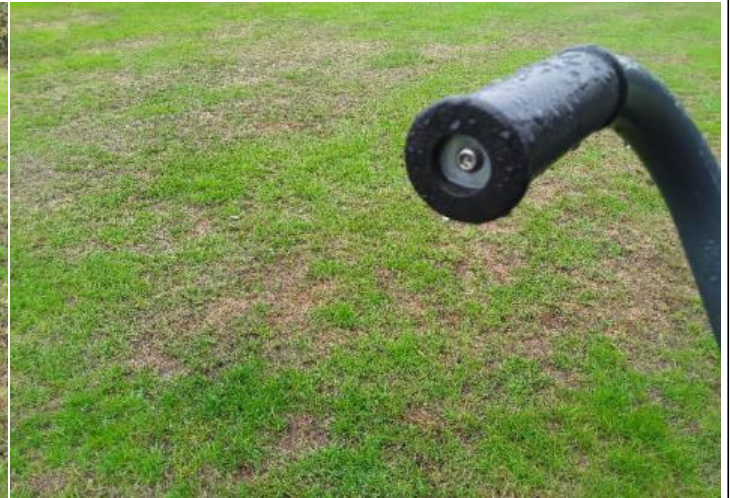
**Item:** Outdoor Fitness Equipment - Rower  
**Manufacturer:** Sunshine Gym

**Finding:** There is/are bolt cap covers missing or damaged on the item

**Action:** Replace missing or damaged bolt cap covers
